Laboratory evaluation of the Dryair drying and heating system for 'moisture flushing' of structural elements

May 2006
Report No. CIM 147/r2

Centre for Infrastructure Management

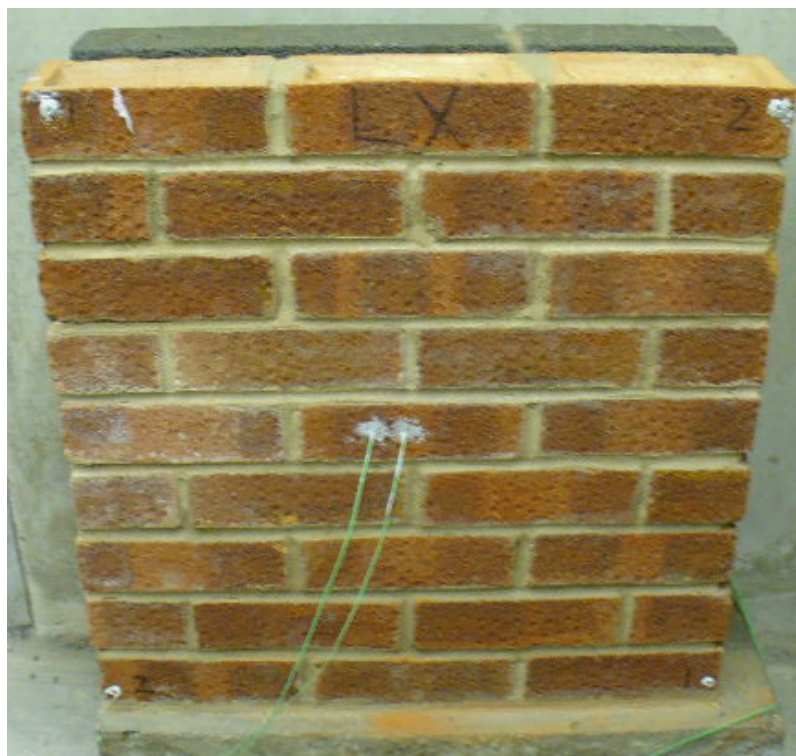
Figure 10: Wall panel LX view after drying process - no visible damage

The surface of the masonry wall panels after drying process showed no visible damage. The other specimens did show degrees of distortion and other damage, most notably the plasterboard which distorted during the wetting process (see Figure 15) and the internal door from which the hardboard facing partly lifted. Other than these examples, the other levels of distortion may be considered tolerable.

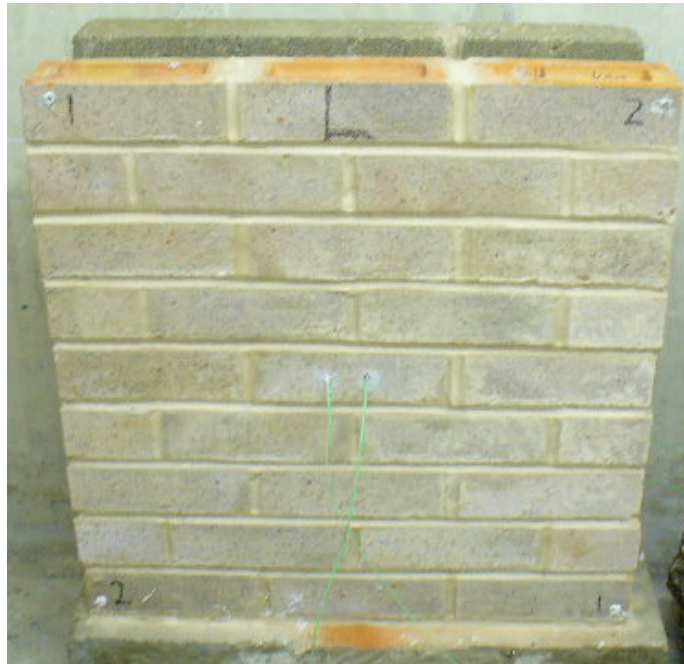
Figure 11: Wall panel L view after drying process - no visible damage

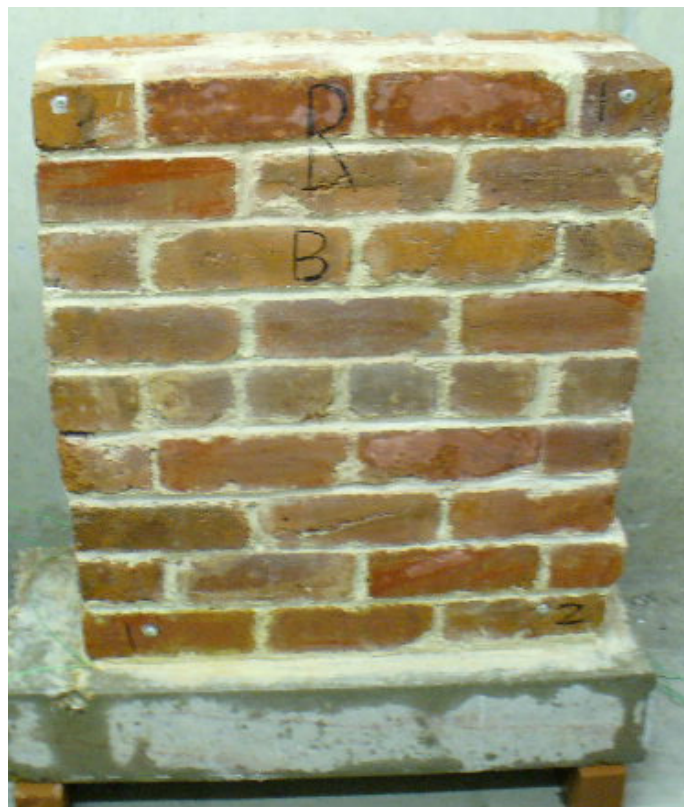
Figure 12: Wall panel R view after drying process - no visible damage

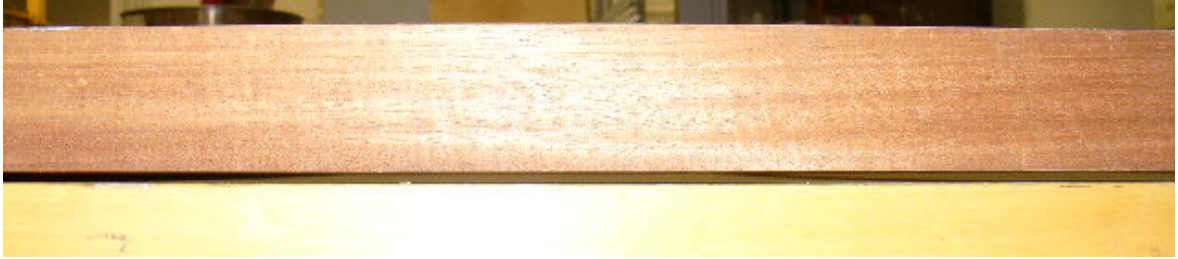
Shrinkage test results for the timber elements indicated that during the wetting and drying process these elements, as would be expected, are more susceptible to warping and cracking than the masonry.

Figure 13: Hardwood external door - distortion 6mm over 1800 mm, after drying

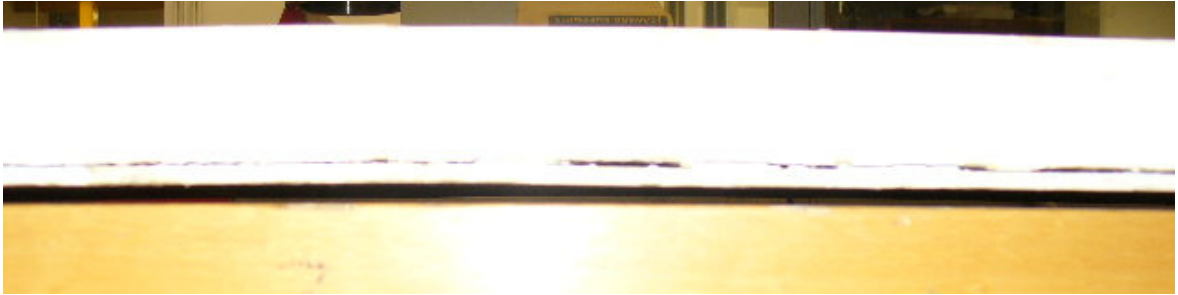
Figure 14: Internal pine door - distortion 12 mm over 1800 mm, and delamination of painted hardboard facing after drying

- The more absorbent and moisture sensitive materials did show varying levels of marginal distortion as a result of wetting and drying although these were generally within acceptable limits with the exception of the plasterboard, which distorted upon wetting, and the interior door where the hardboard facing to one side became partly detached, again during the wetting phase.

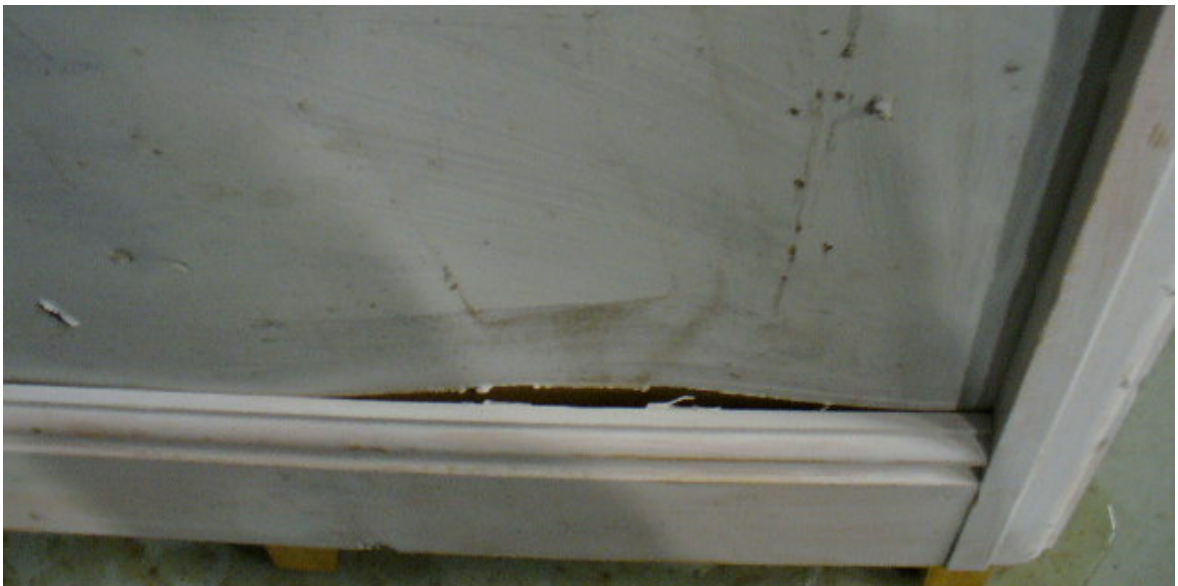
Figure 15: Plaster board panel - distortion after water saturation
