Balistraat, Dordrecht

9th – 10th June 2006

The Property

The problem

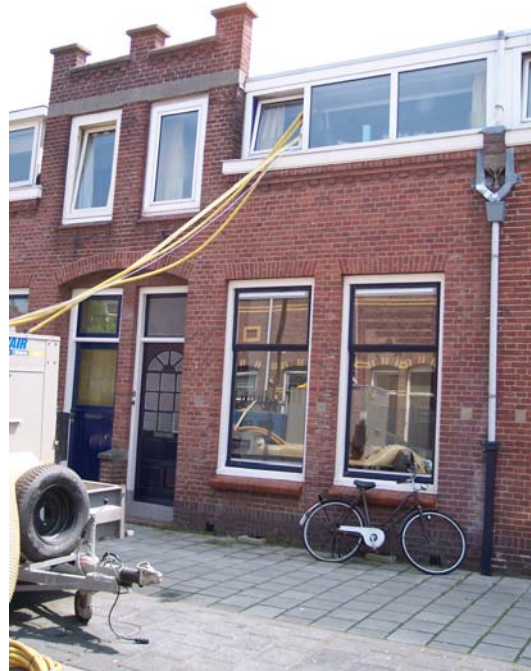
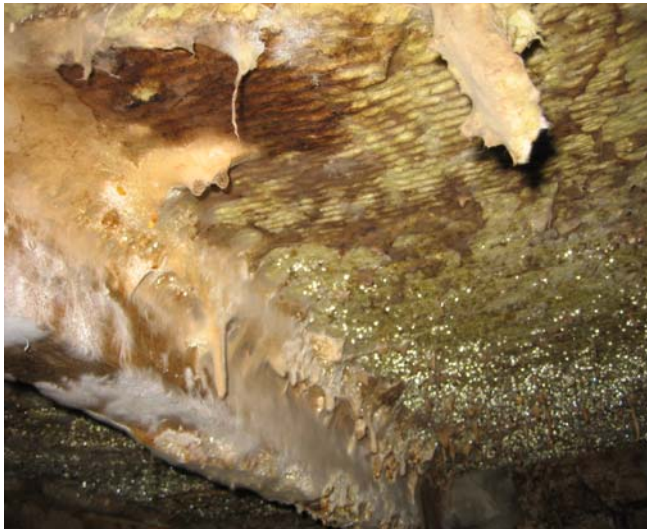
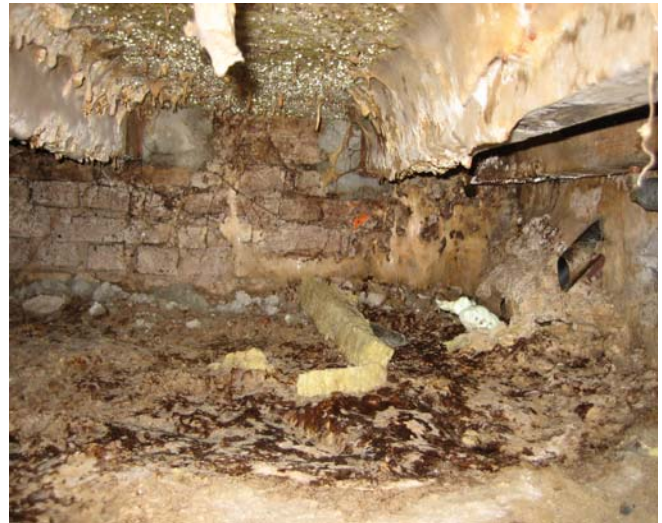
The sub floor area including sand substrate, walls and joists were heavily infected with *Serpula Lacrymans* (dry rot), as can be seen in the photo's below, joists had over 100mm of mould built up, which was heavily saturated with water.

The conditions, wet, dark & humid were the ideal spawning ground for this infestation, with a temperature band between 5°C and 35°C & a large volume of timber (food source)

The 2 photo's show the heavy infestation, along with the moisture beads, clearly visible

All living organisms die when subjected to the extremes of temperature, *Serpula Lacrymans* is no exception. This particular mould requires a temperature in excess of 54°C for a period exceeding 2 hours.

The temperature and times quoted, relate to temperature and time within the matrix of the host material, they **do not** refer to air temperatures. For this effect to take place, the Dryair system has to raise the air temperature to at least 70°C and in many instances much higher.

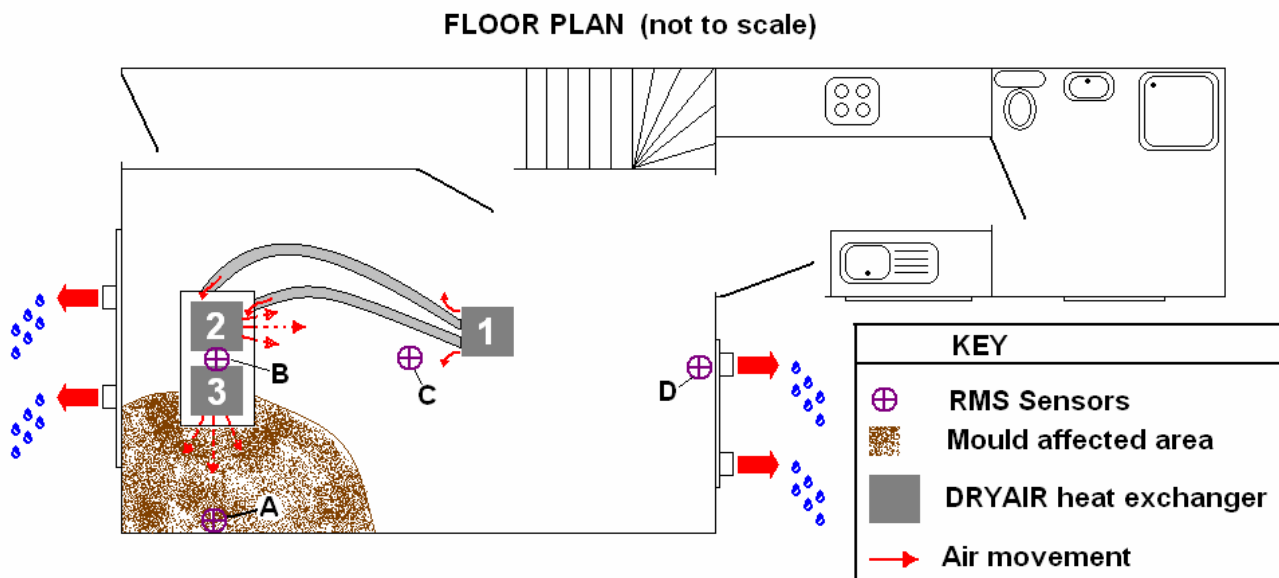
DRYAIR used a 180-EU heater with three PHE 25-EU heat exchangers to;-

1. Raise the air temperature
2. Dry the affected walls and timbers
3. Kill the infestations

Two heat exchangers, numbers 2 and 3 on the floor plan, were lowered into the sub-floor void.

Heat exchanger 3 was positioned to give maximum heat in the mould contaminated area whilst heat exchanger 2 was positioned to encourage air movement and dry the saturated timbers.

Heat exchanger number 1 had two ducts fitted to a four port air diffuser. The ducted air used the "moisture flush" system to create a positive pressure in the sub-floor floor void and force humid and contaminated air out of the under floor vents.

The remaining two ports provided hot air to kill and dry the mouldy wall and to prevent secondary damage from condensation.

Remote monitoring probes (RMS) were fitted in four areas to ensure even heating and drying.

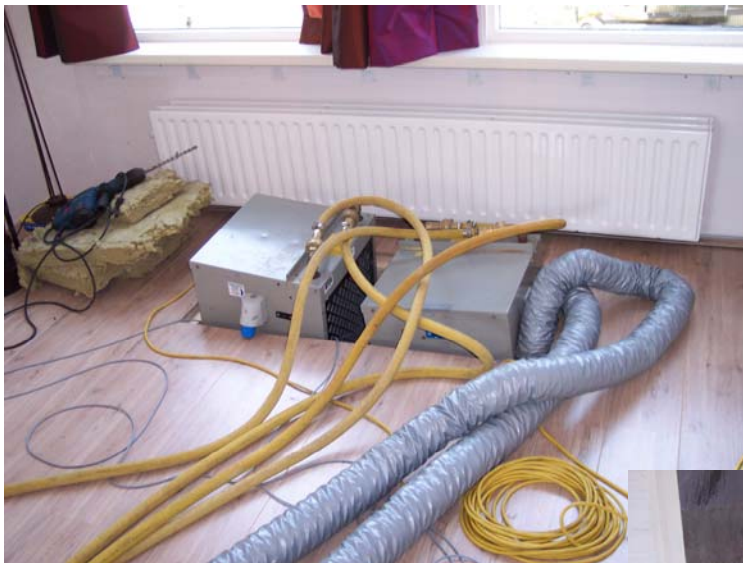
Figure 2

Heat exchangers, numbers 2 and 3 on the floor plan, lowered into the under floor void prior to being sheeted over.

Note; the two grey ducts providing positive pressure for the “moisture flush”

The Dryair PHE 25-EU's are 25kw heat exchangers which move 1500 m³ of hot air every hour. As the under floor void was approximately 50m³, the air was re-circulated through the heat exchangers (numbered 2 & 3) 60 times every hour.

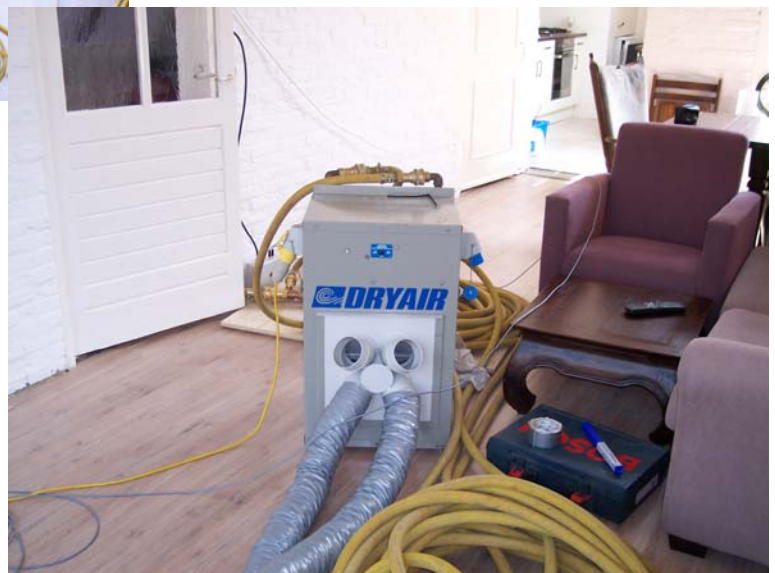
Figure 3

Heat exchanger, numbered 1 on the floor plan, providing the positive pressure through the ducting and preventing secondary damage with the two open ports.

The heat exchanger (number 1) creating the "moisture flush" ensured that humid / contaminated air left the building at a rate of 750 m³ per hour.

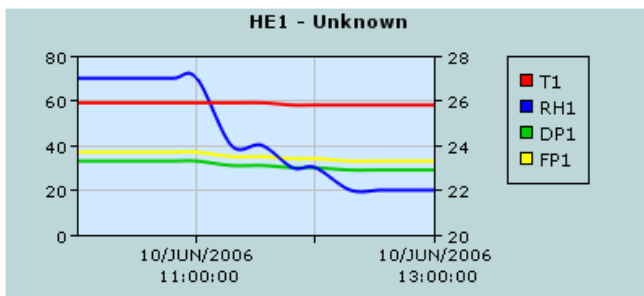
These graphs show the last four hours of data from the probes in positions A – D in the floor plan shown on page 2.

The lines of importance are; - Red showing temperature in °C. Blue showing RH in % and Green showing dew point.

The scales are;- on the left, Temperature and on the right, RH

Graph for probe in position A

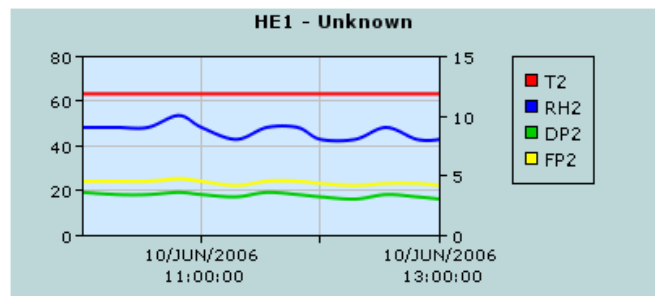
Graph for probe in position B

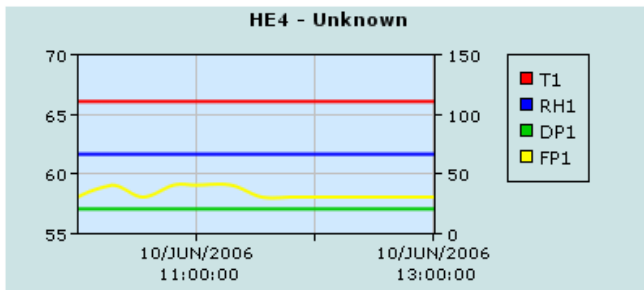
Graph for probe in position C

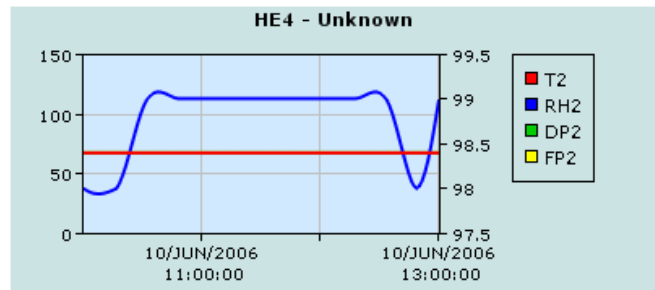
Graph for probe in position D

note:- this probe was reading temperature only)

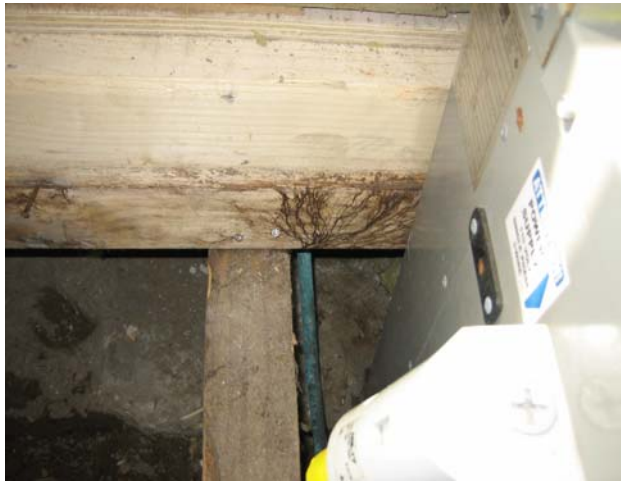
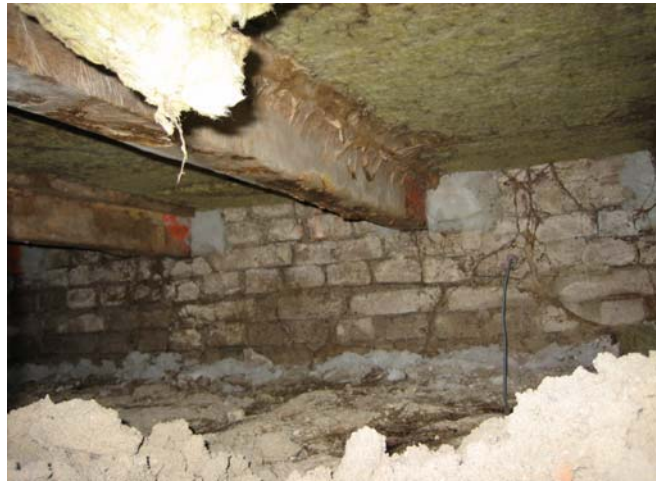
The 2 pictures above clearly show the dried and shrivelled remains of *Serpula Lacrymans*

The Dryair system was switched off at 15.00 on the 10th having ran for just 27.5 hours. During this period, the mould had been held at a temperature in excess of 60 °C for over 12 hours and had been completely destroyed. The saturated wood had been dried to 9% RH and the sand sub-strait had been dried to 100mm deep.

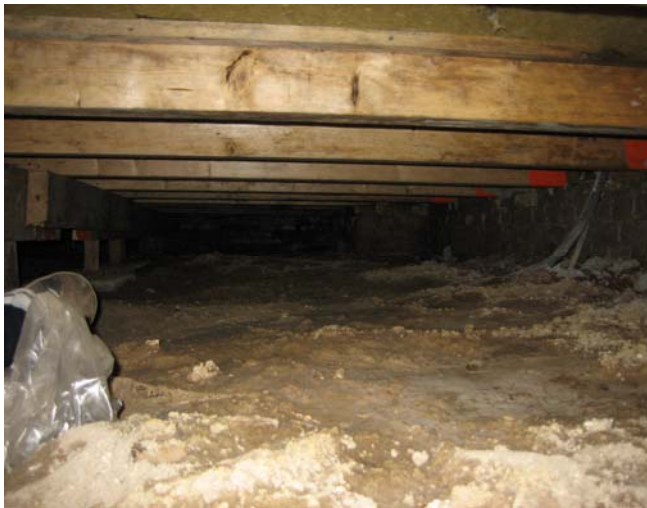
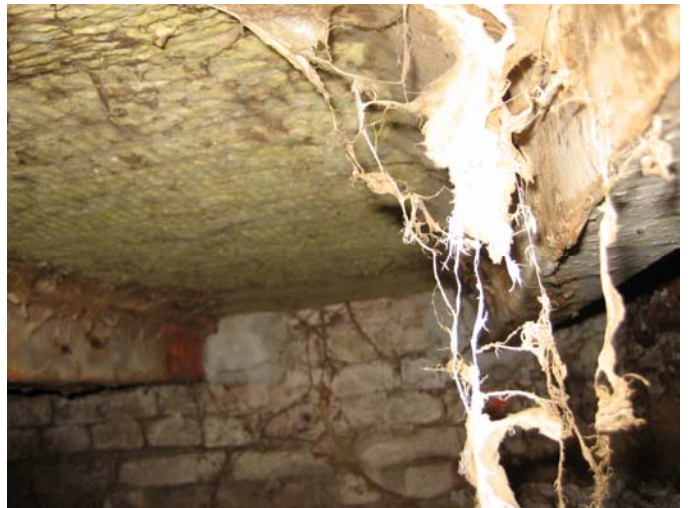
Once again clear evidence of the effects of controlled heat on the infestation in question.
