A Finn House, Libel, Leusden

5th – 8th June 2006

The Property

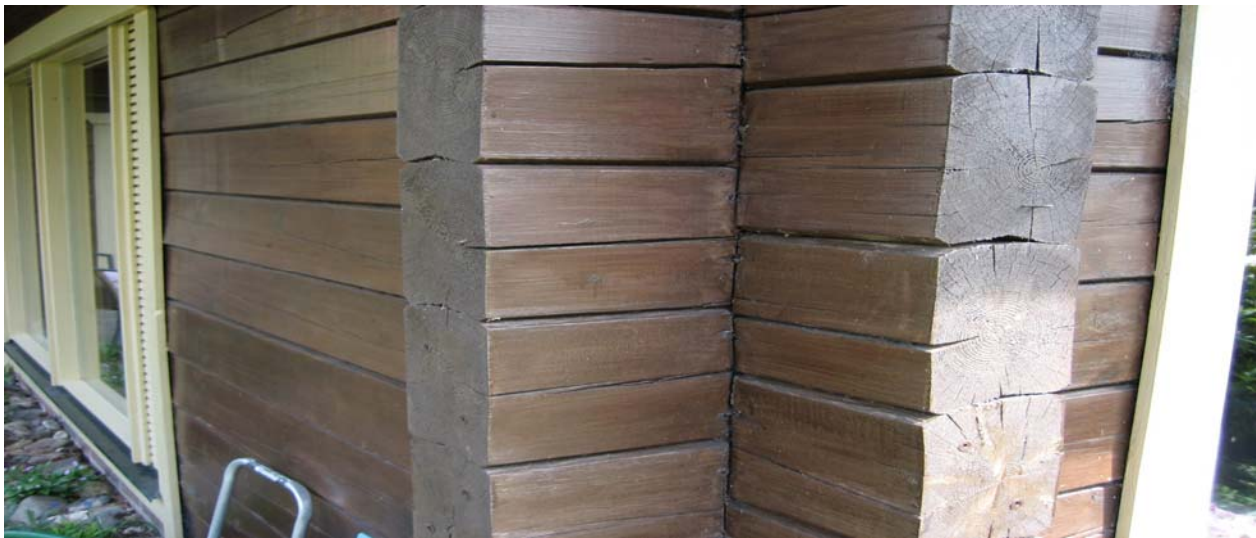
An infestation of *Hylotrupes bajalus* (House longhorn beetle), has been active for sometime within the matrix of timbers in numerous areas throughout the property, both internally and externally. The beetle has the ability to eat the heart out of timbers without any visible signs, it is only when the oval shaped external holes (6-8mm) appear, that the infestation is generally noticed.

It is often the case at this stage, that the property has suffered severe structural problems, however in this instance this was not the case. Some stress fractures were evident on the solid pine sections; these however, were in this condition when the client moved in.

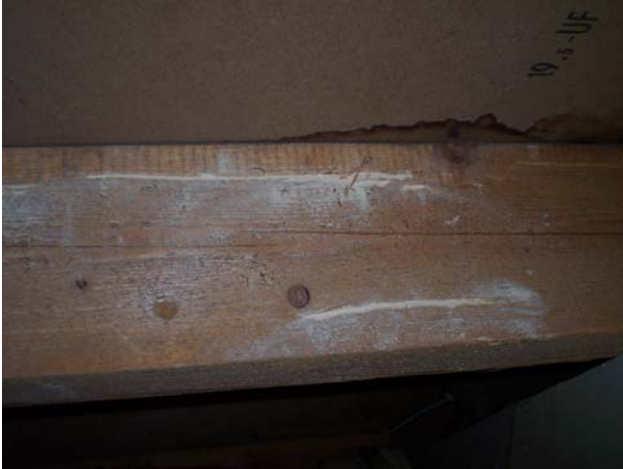
Figure 2

Figure 2, looking at a roof truss in the loft, shows a rare example of the larvae tunnel when it breaks through the surface. These two tracks are nearly 5mm in diameter.

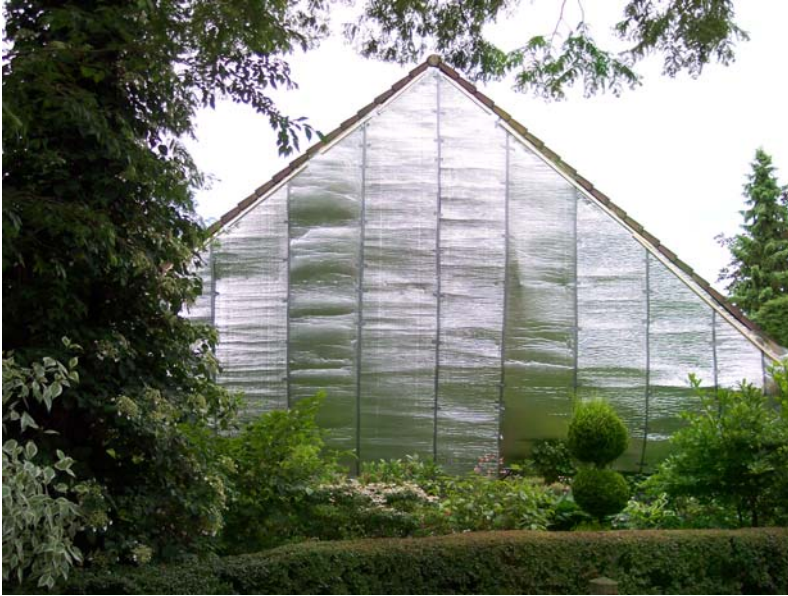
Figure 3

Figure 3. Viewed from the front. The insulating layer was attached to the soffit boards, supported at the balcony and sealed at the floor. An access flap was created by the front door. To gain entry with-out losing heat.

A large percentage of the long horn beetle had entered the timber from the outside so it was imperative that the outside of the house was heated to the same temperature as the inside. Wood is an excellent insulator; therefore the solution was to heat the internal & external sections of the structure. This was done by wrapping the entire house with an insulating layer to create a void that could be heated; in this instance foil backed bubble wrap was used.

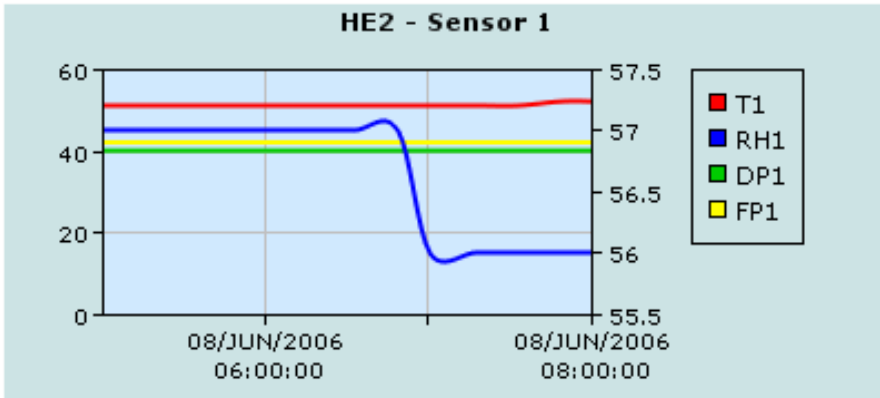
HE2 - Sensor 1 =
Temperature / RH in the roof
beam in the loft
