Laboratory evaluation of the Dryair drying and heating system for 'moisture flushing' of structural elements

May 2006
Report No. CIM 147/r2

Centre for Infrastructure Management

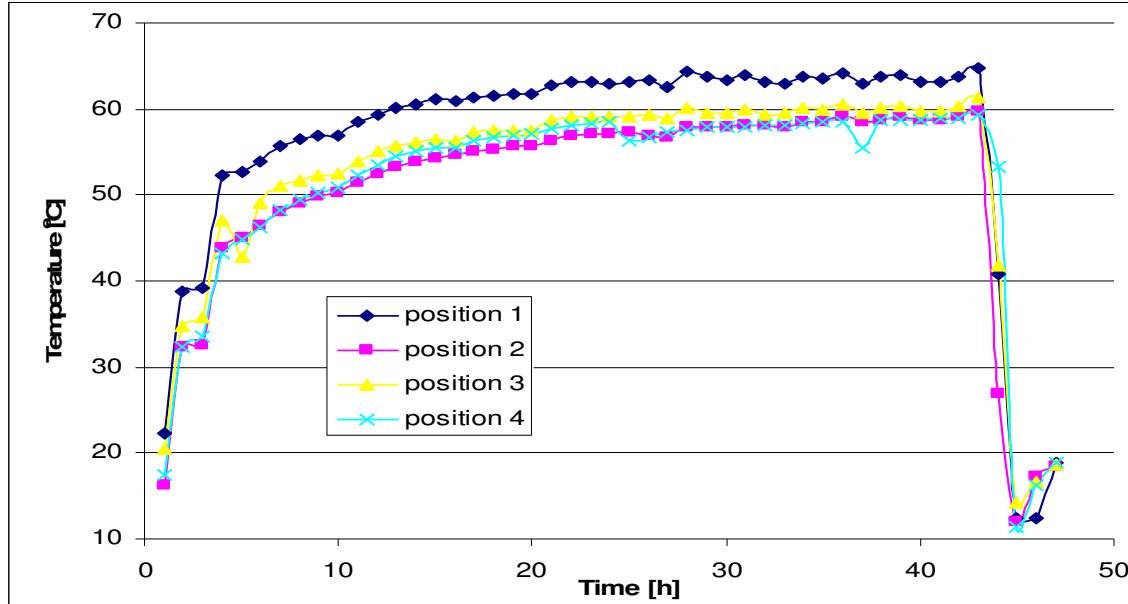
Figure 5: Heat distribution in the chamber during the drying process (thermocouple locations as indicated in Figure 3).

Temperature measured during drying process (Figures 5 and 6) indicate that there are no significant differences of heat distribution after 20 hours heating between bricks panels and heating chamber. After 20 hours during heating process the thermal equilibrium state in the chamber has been achieved at 70°C.

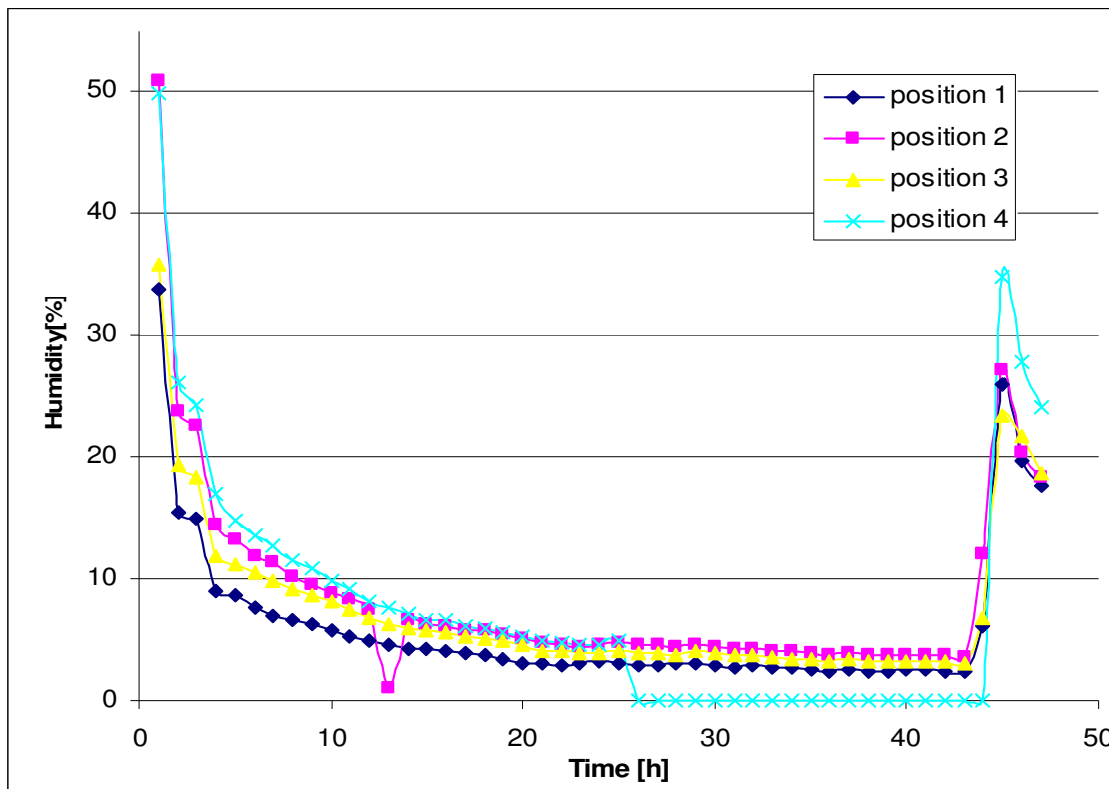
Figure 7: Humidity levels during drying process (sensors locations as indicated in Figure 3).

The humidity measurement results (Figure 7) demonstrate that after 20 hours of drying in the chamber the humidity level within the drying chamber is at 5% and remains at a similar level until the drying is completed and the heat turned off.

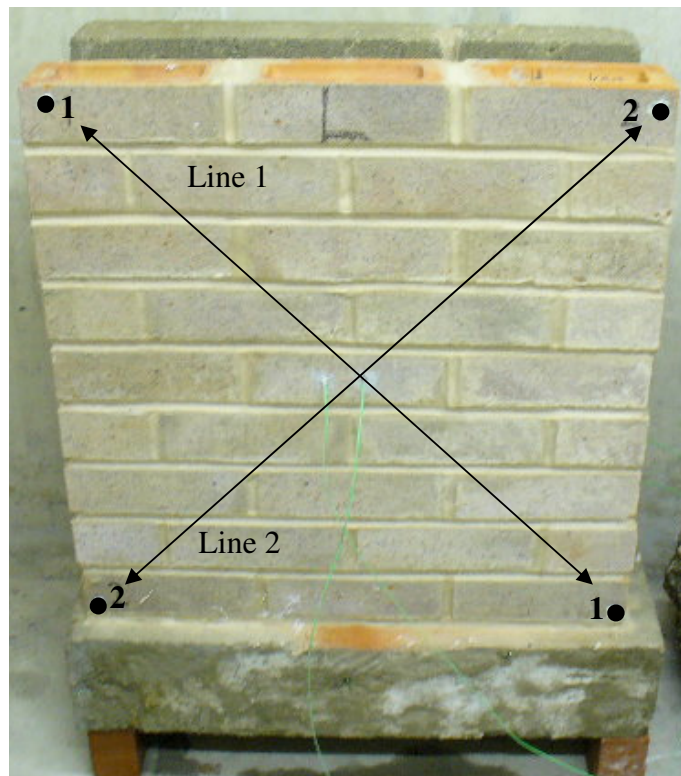
Figure 8: Strain monitoring locations on wall panel

Determination of the shrinkage strain in wall panels and timber doors has been made using Demec equipment in accordance with the British Standard - BS 1881-206:2006. The strain in the wall panels was measured of the locations shown in Figure 8. Figure 9 gives a schematically view of the strain monitoring locations on the doors.

The maximum of differential strain in the wall panels has been observed between the laboratory air cured and immediately after drying. These results can be largely explained by the thermal extension of wall panels and after cooling the differential strain level was reduced to approximately 100 microstrains. This level of microstrain should not be sufficient to cause a significant risk of tensile cracking in the wall panels and no such cracking was observed during the visual inspections.

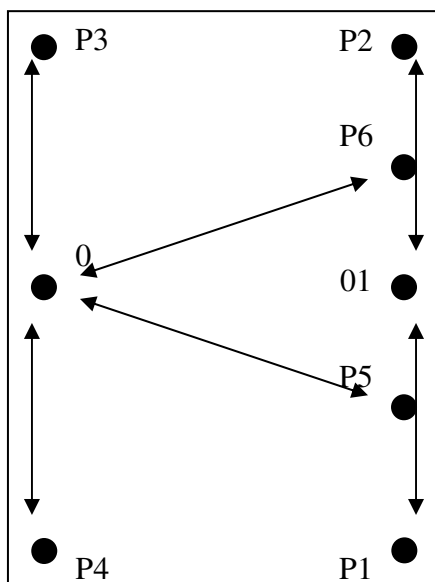
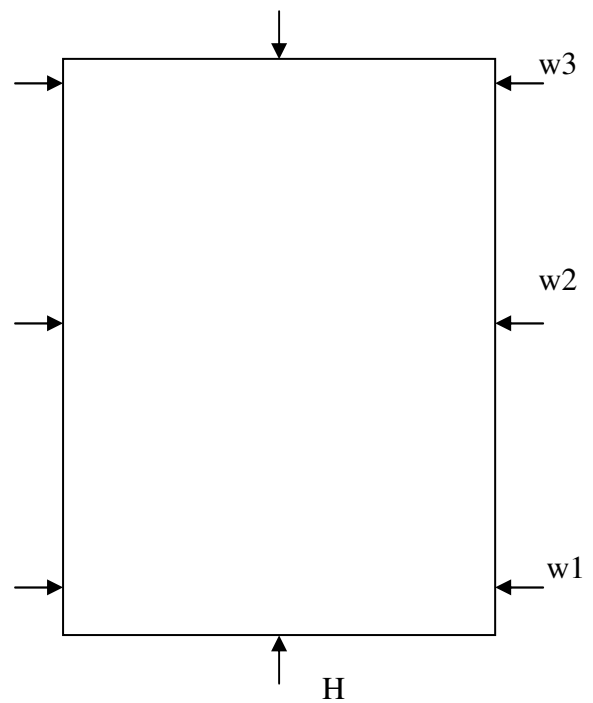
Figure 9: a) Demec point locations on door panels, Locations of dimension measurements.

Shrinkage test results for the timber elements indicated that during the wetting and drying process these elements, as would be expected, are more susceptible to warping and cracking than the masonry.
